**Re: HPA APP ID #14829**

**Fish Ladder Monitoring Report for December 14<sup>th</sup> through December 20<sup>th</sup>, 2020**

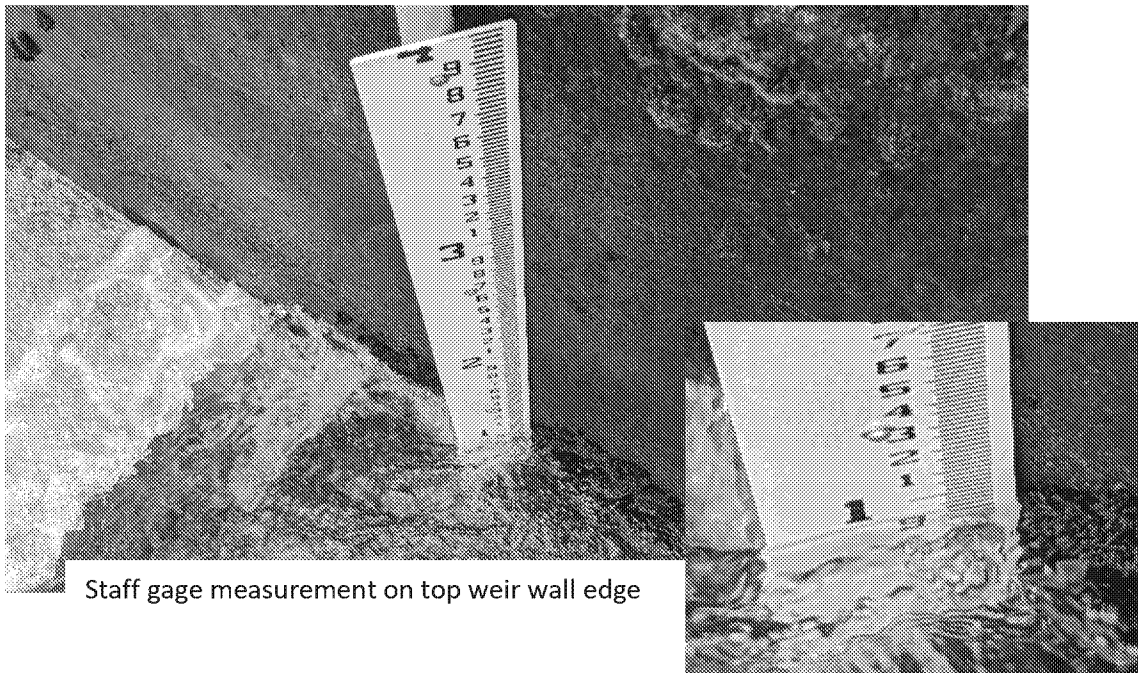
Staff gage measurement on top weir wall edge
